ROLL-ON/ROLL-OFF (RO/RO) MERCHANT VESSEL
OFFLOADING FACILITY TESTS WITH THE
CALM WATER RAMP (CWR)
(COTS CNO PROJECT 299, DT-IM-2)

May 1983

DTNSRDC/SDD-83/5

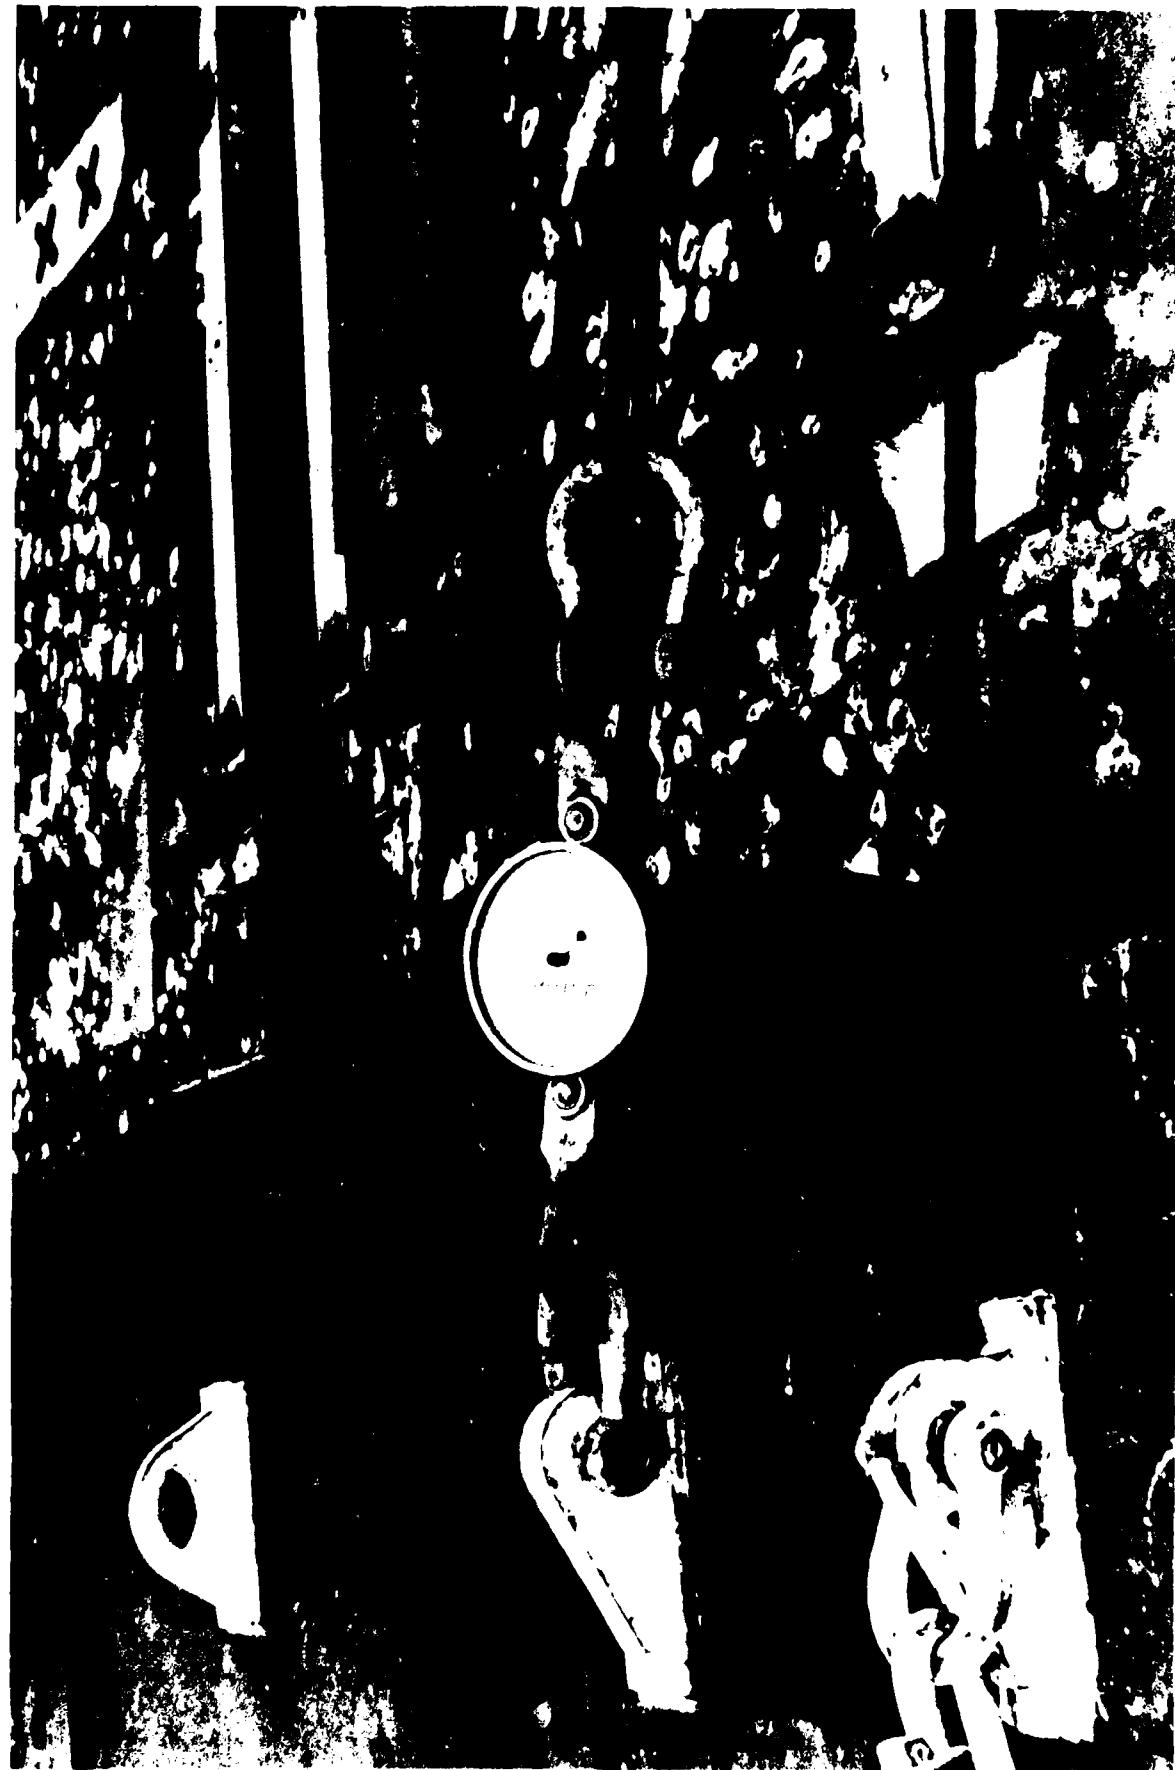
Figure 14 - Dynamometer Reading During CWR Pull Test

The actual force required to overcome static friction was approximately twice the 10,250 lb shown by the gauge maximum indicator in Figure 14, or 20,500 lb. The force required to move the ramp once the static force was overcome was approximately twice the 5,500 lb shown in Figure 14, or 11,000 lb. These figures indicate a coefficient of static friction of approximately 0.29 and kinetic friction of approximately 0.16. The second of these figures compares somewhat closely with the predicted handbook value of 0.13 for the movement of polyethylene on wood (lightly sanded). The rough finish of the wood dunnage probably contributed to the higher coefficient of kinetic friction. The high value of static friction has been determined to be the result of two factors. The first factor was the rough cut and varying thickness of soft lumber which gave the dunnage a rough surface texture susceptible to compression. The second factor was that the polyethylene foot pads had 90-deg edges, which suggests that the

high value of static friction had more to do with the ramp feet getting over a self induced ridge in the dunnage than with overcoming true static friction. For this reason it is recommended that the edges of polyethylene foot pads be beveled at a 45-deg angle to facilitate movement of the ramp on wood dunnage.

- a. The edges of the polyethylene foot pads of the CWR be beveled at a 45-deg angle to facilitate movement of the CWR on wood dunnage.
- b. The fender support structure (pipes behind the foam-filled fenders) should be reduced in overall length by approximately 1 ft to prevent damage during CPF mooring.
- c. Using the test data, mooring procedures should be updated to ensure that an adequate number of lines are provided to accommodate the "worst case" mooring situation.
- d. A special set of padeyes should be installed on the ramp to allow

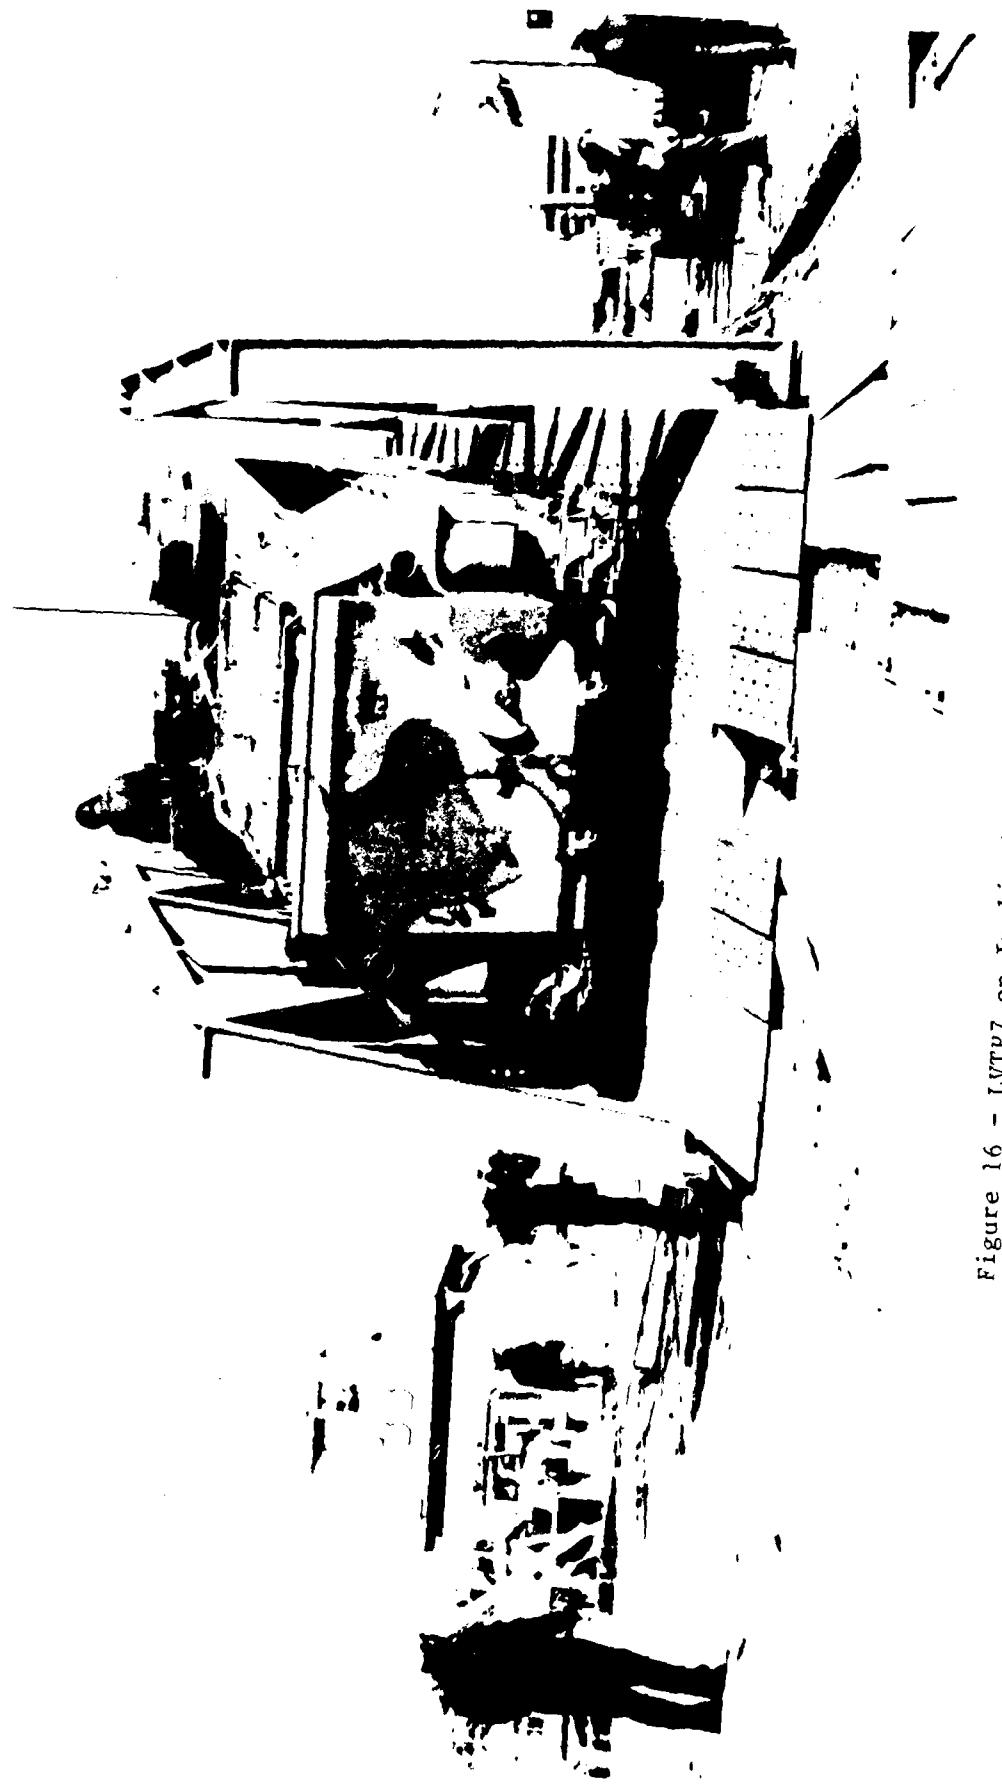
Figure 16 - LVTP7 on Inclined Ramp (View 1)

The first vehicle to negotiate the inclined CWR section was an LVTP7 (see Figures 16 and 17). The clearance on each side of the vehicle is shown in Figures 18 and 19. The useable width of the ramp is 14 ft and the width of the LVTP7 is 10 ft 9 in. The only problem encountered was that the 3/4 in. diameter traction studs on the ramp tended to gouge the rubber traction pads on the LVTP7 (see Figures 20 and 21). Since only small amounts of rubber were gouged from the pads, this problem was not considered to be significant.

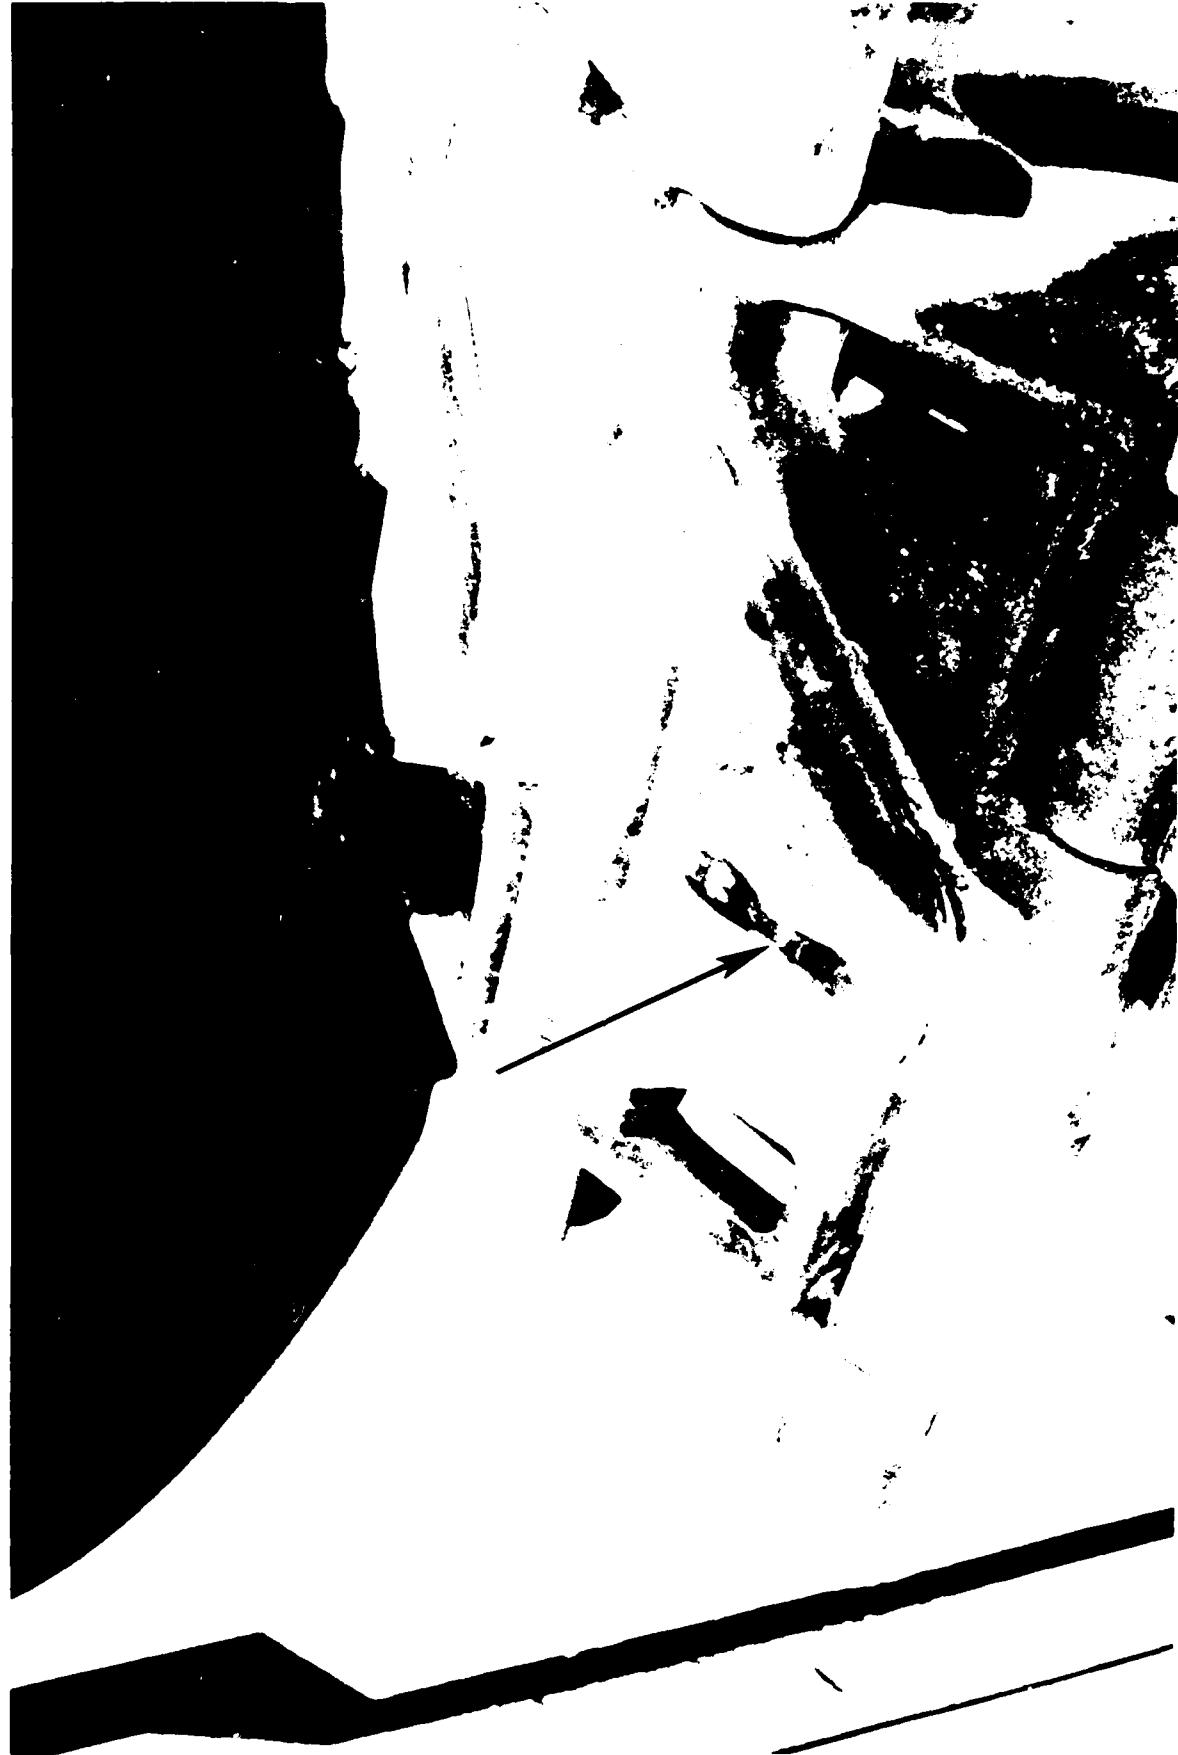
Figure 20 - Effects of Driving on Traction Studs

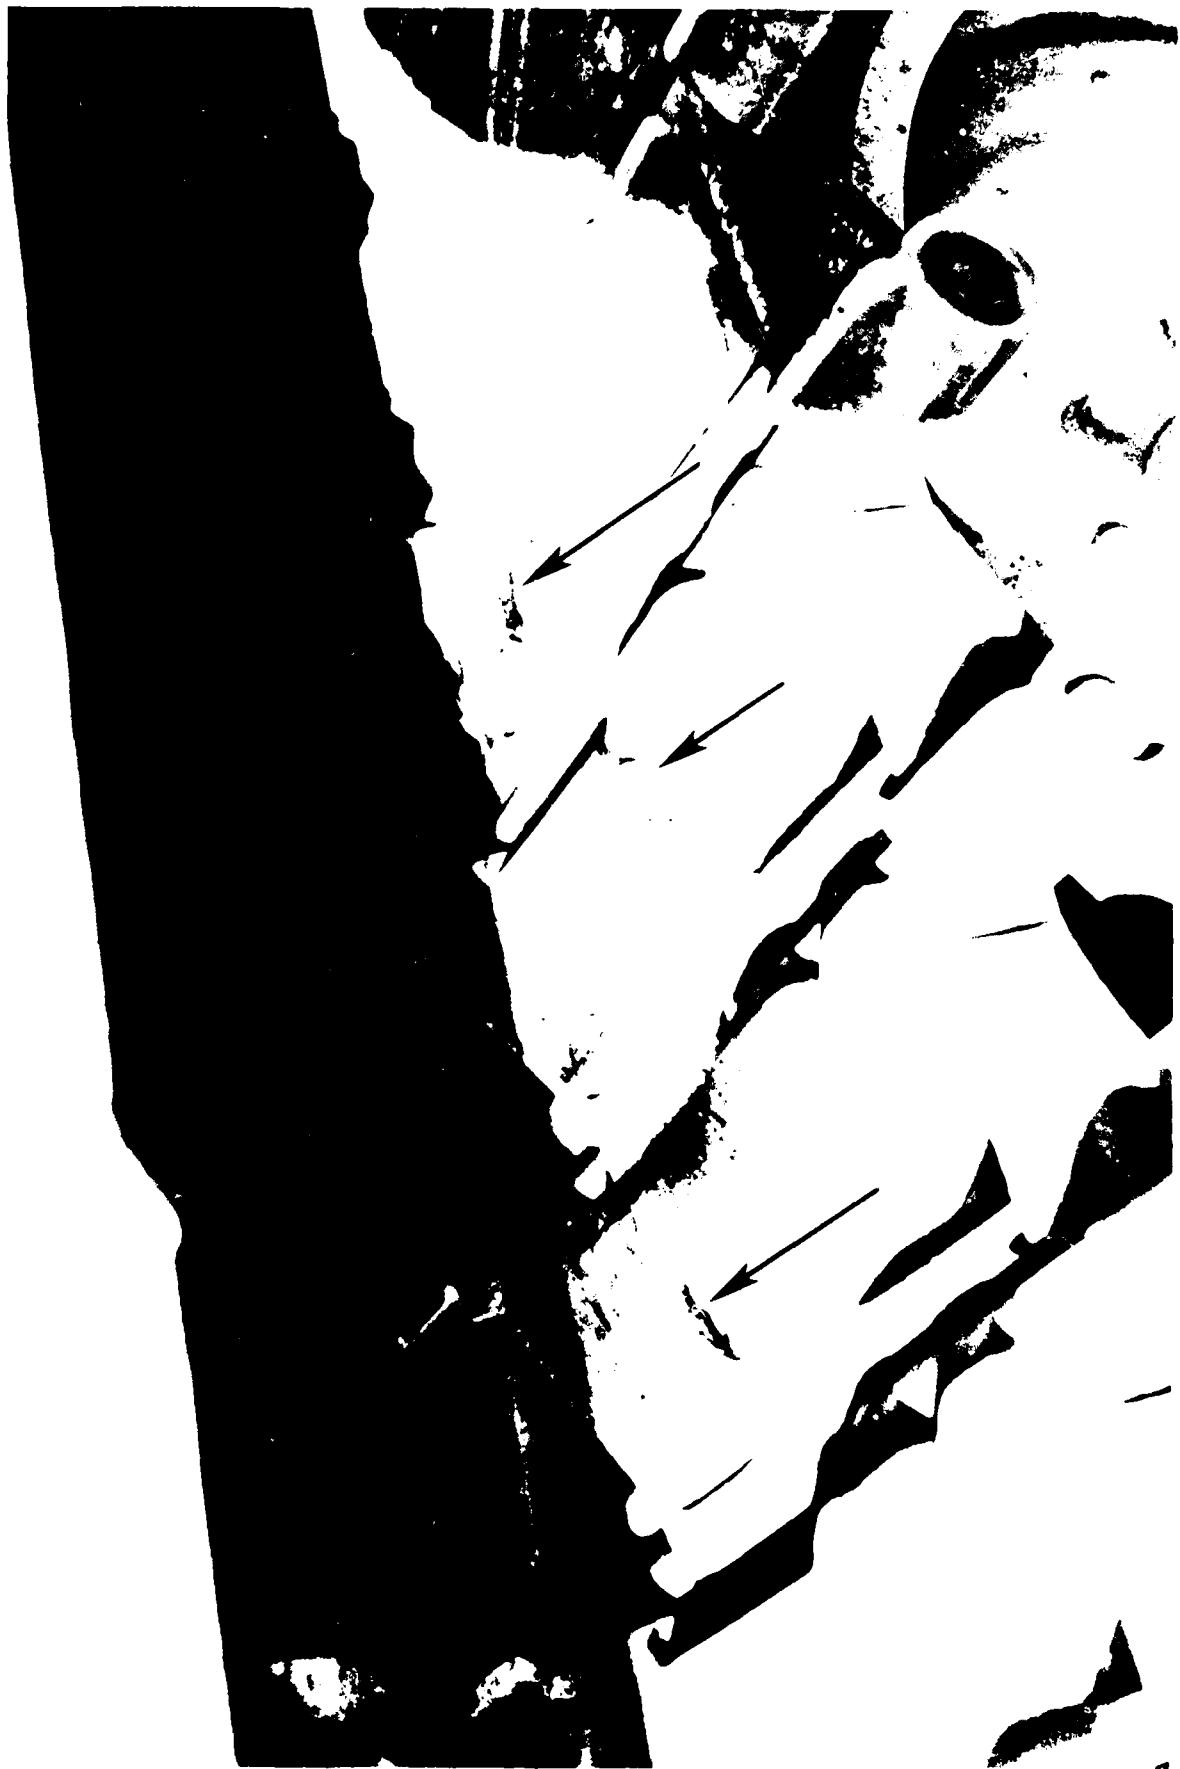
Figure 21 - Tread Damage From Traction Studs

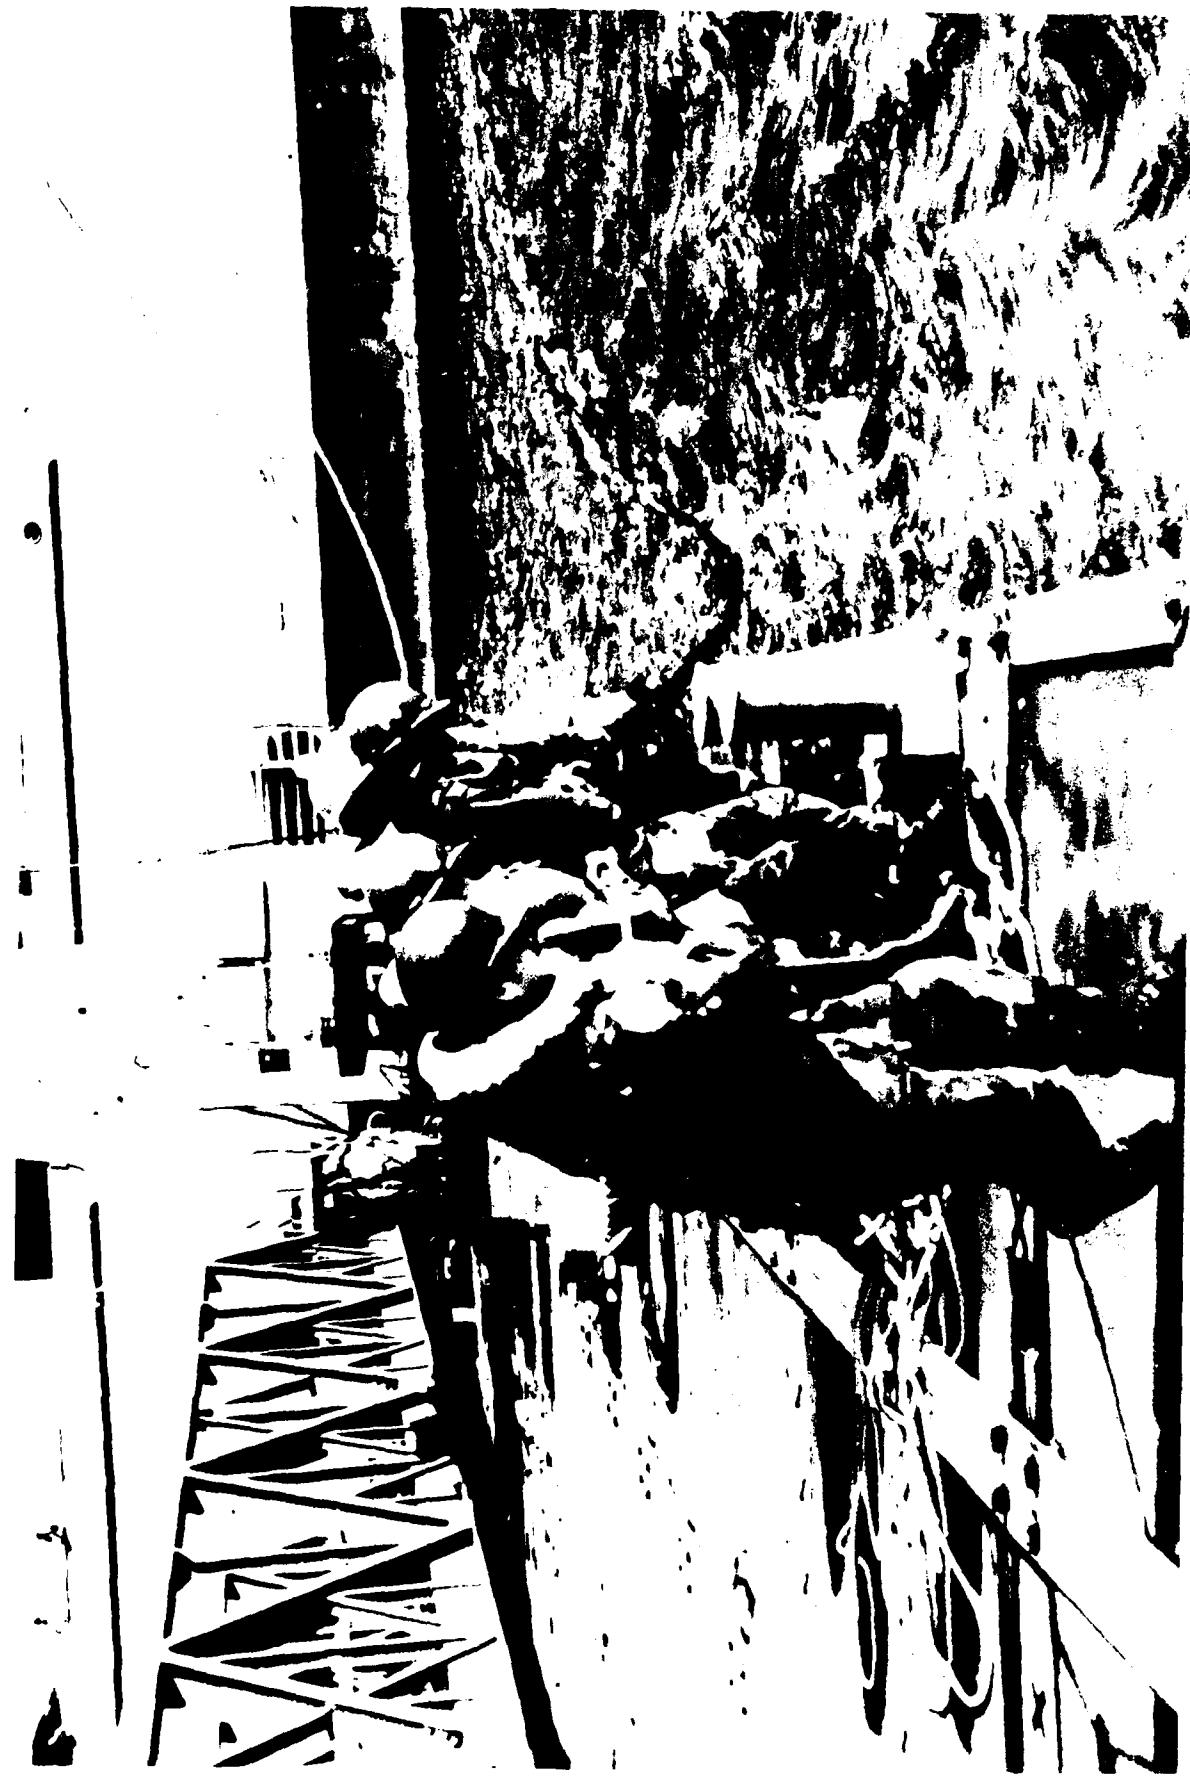
Figure 35 - Crew Pulling Line to Last Set of Bits

The CPF, which had a B section installed to facilitate LCU marriages, was moved to the ship from the PHIBCB TWC Base by two warping tugs. The tugs were tied off to the B section as illustrated in Figure 32. On 17 November, the seas were calm with no appreciable wind. The warping tugs positioned the CPF alongside the ship with no difficulty. The approach speed was approximately 1 knot. The fender absorbed the impact with the ship without incident. The CPF was moored to the ship through the use of five mooring lines provided by the ship. The sequence of passing the mooring lines and the actual time each line was secured on the CPF is shown in Figure 32. The total mooring time was 35 min. Figures 33 through 37 show the mooring operation. Note that only four personnel were required to pull the longest floating polypropylene mooring line to the appropriate bitt (Figure 35).

position it transversely until the ship's lines were passed and secured. Because of the number, length, and distance of the passed lines, a minimum of four line handlers is required (see Figure 35). Additionally, radio contact with the ship must be maintained, preferably with the passing of a Navy radio to the ship.

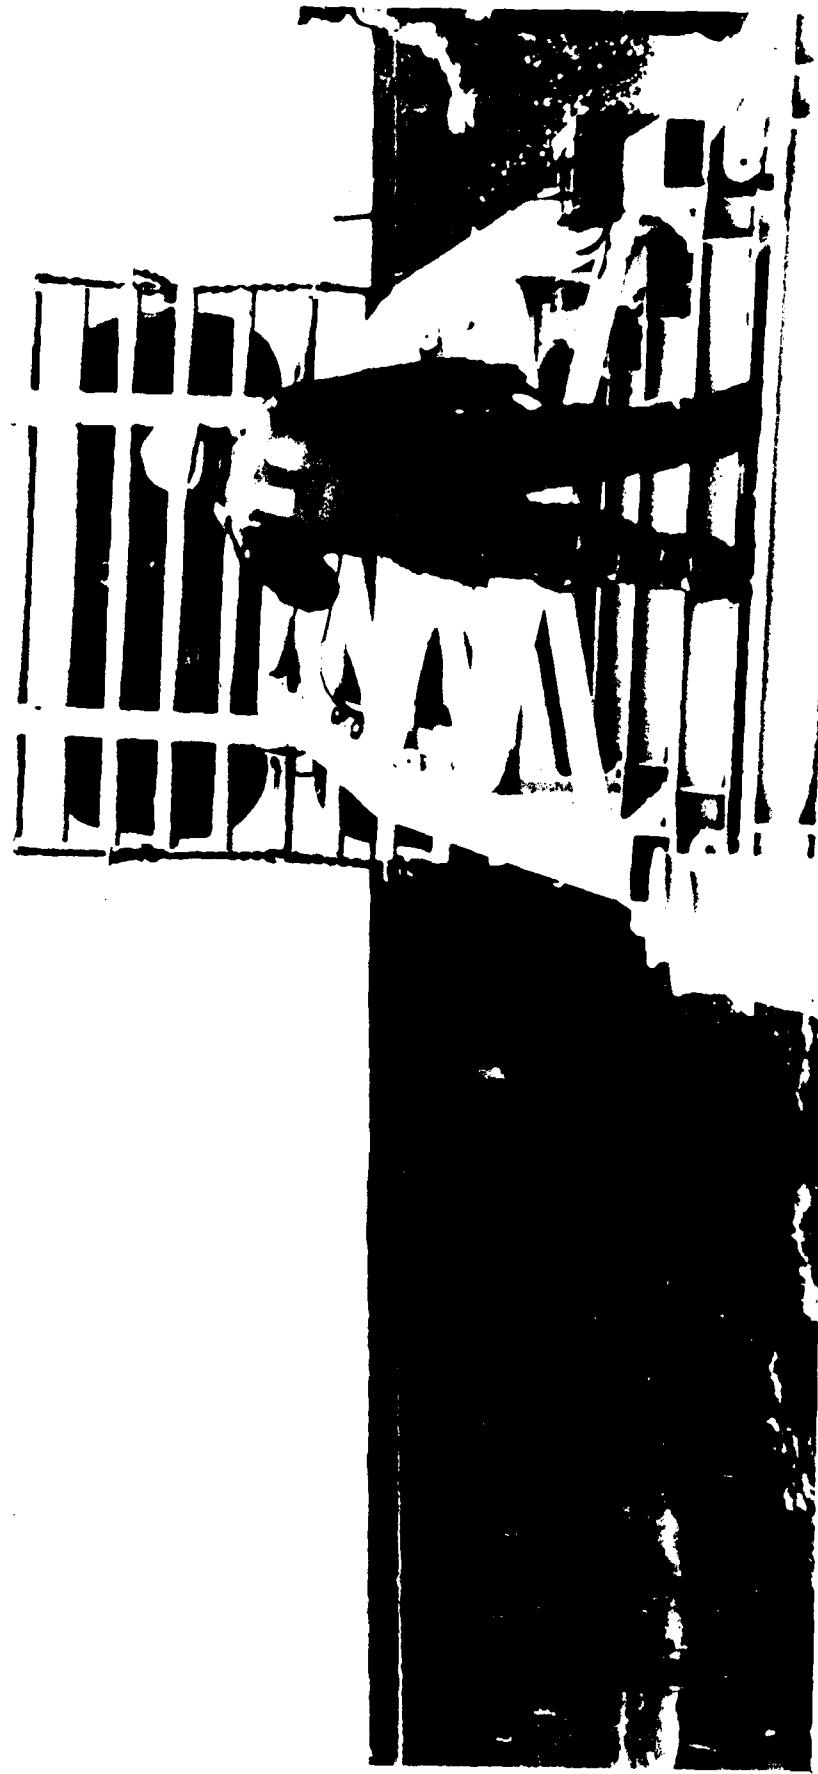
Figure 38 - CPF Approaching at an Oblique Angle

The approach to the ship on 18 November was much faster than the previous day and at an oblique angle (Figure 38). It was estimated that the CPF hit the ship's side at approximately 2 knots. This impact damaged several of the fender support pipes on one fender assembly. Figures 38 through 42 show the CPF approaching the ship, the actual impact, and the resulting damage. The approach angle to the ship was necessary to account for current and wind. The damage to the fender support pipes could have

NOTE FENDER STRUCTURE CONTACT WITH THE SHIP'S SIDE

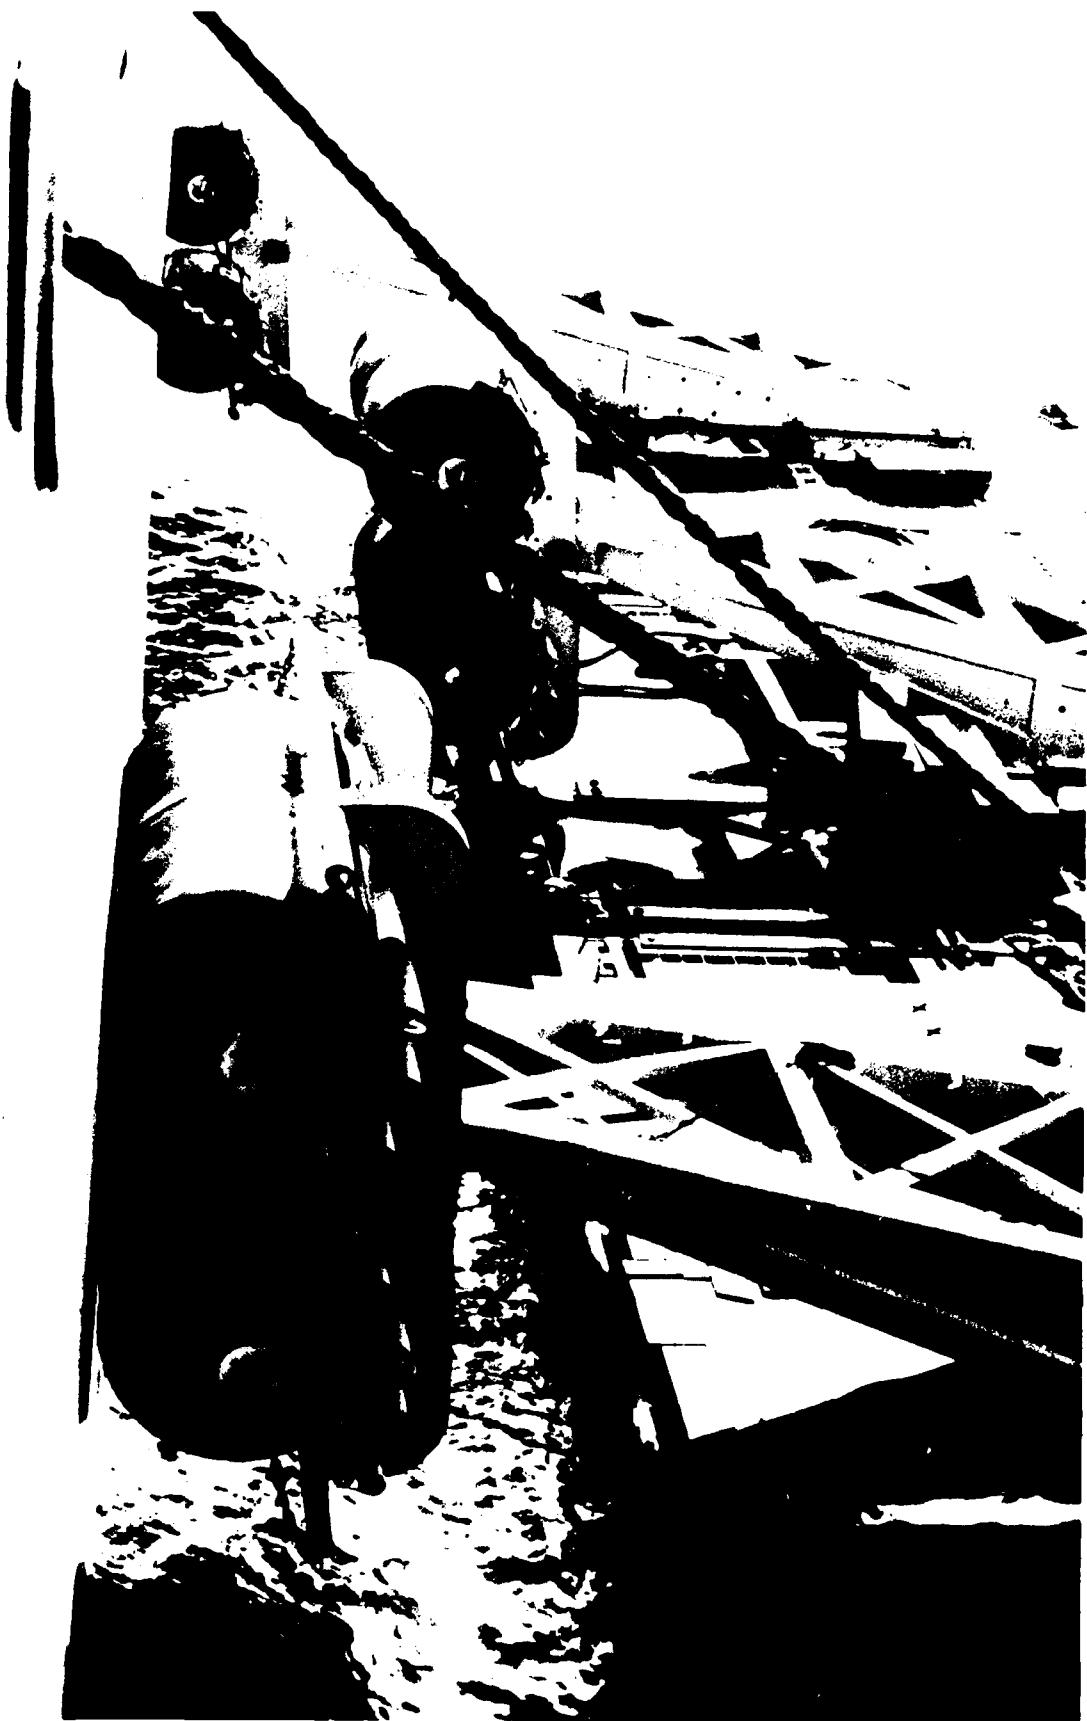
Figure 43 - CPF Fenders Against Ship on 17 November

The fender assemblies worked well in keeping the CPF structure clear of the ship and also in accommodating relative motion between the CPF and the ship. Figures 43 through 46 illustrate the arrangement and operation of the fenders. Some movement of the entire fender support frames on the CPF was noted on 18 November when the wind increased to about 10 knots with a significant wave height of approximately 2 ft. The movement was in "tolerances" in the bolting pattern between the foundation and ramp structure. Upon inspection, it was determined that lock washers were missing from the bolts. The bolts were tightened which reduced the movement (see Figures 47 and 48).

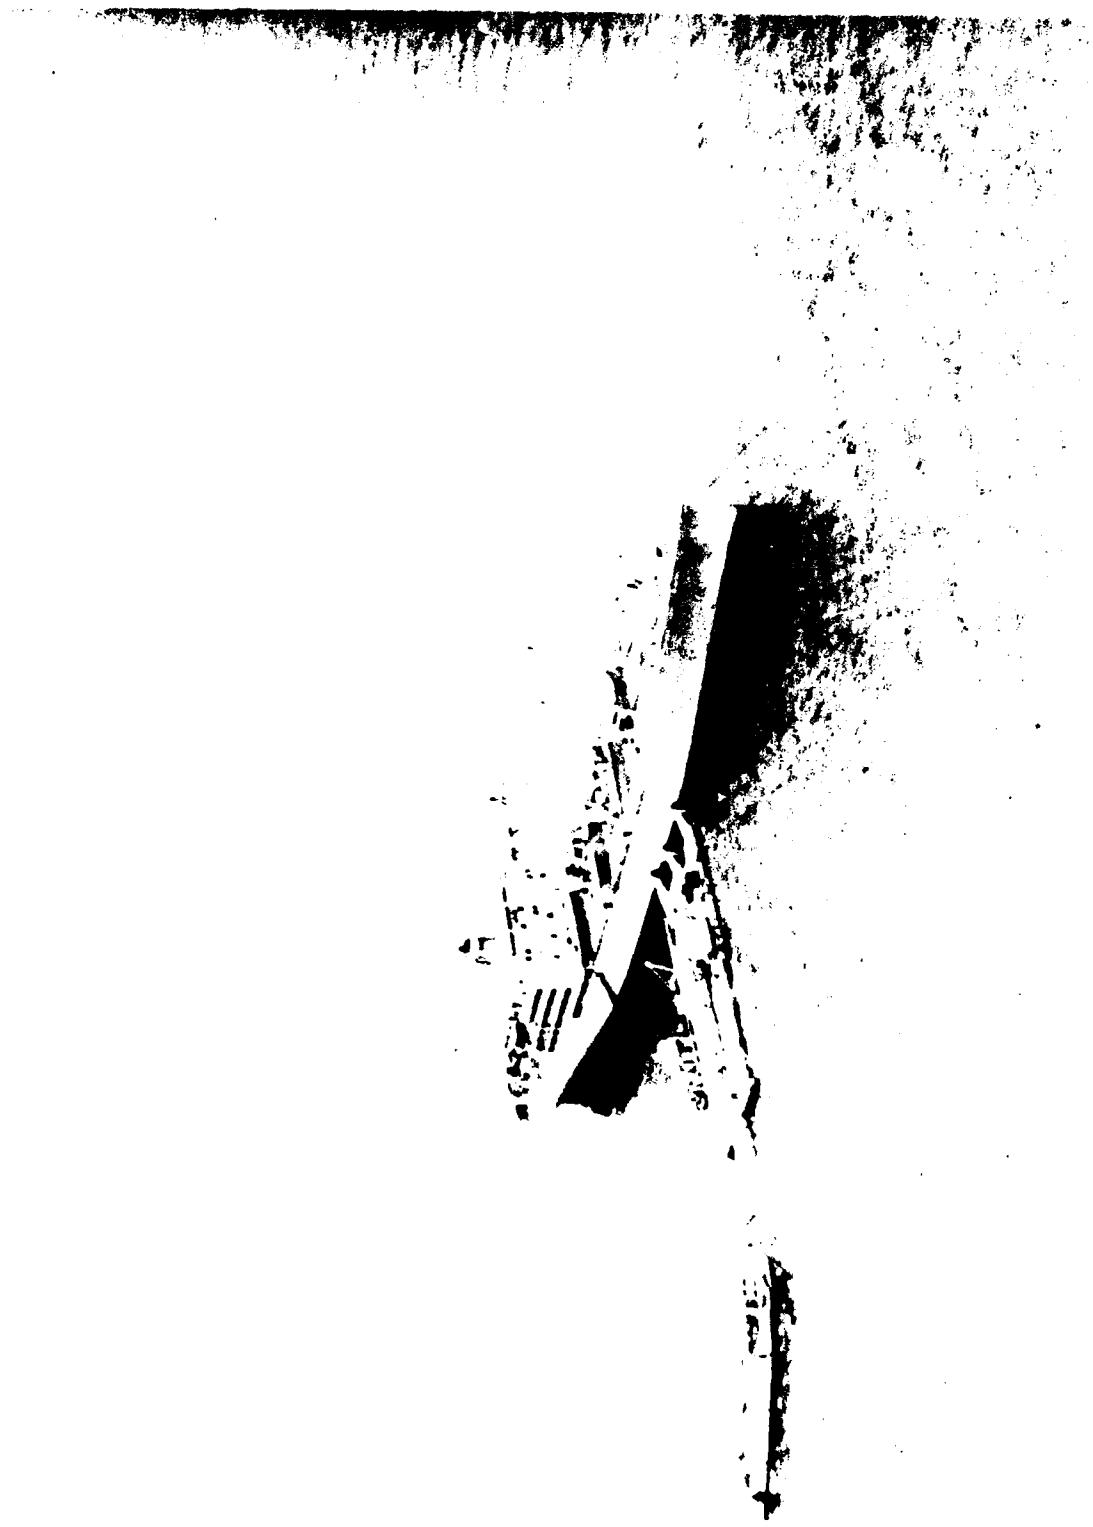
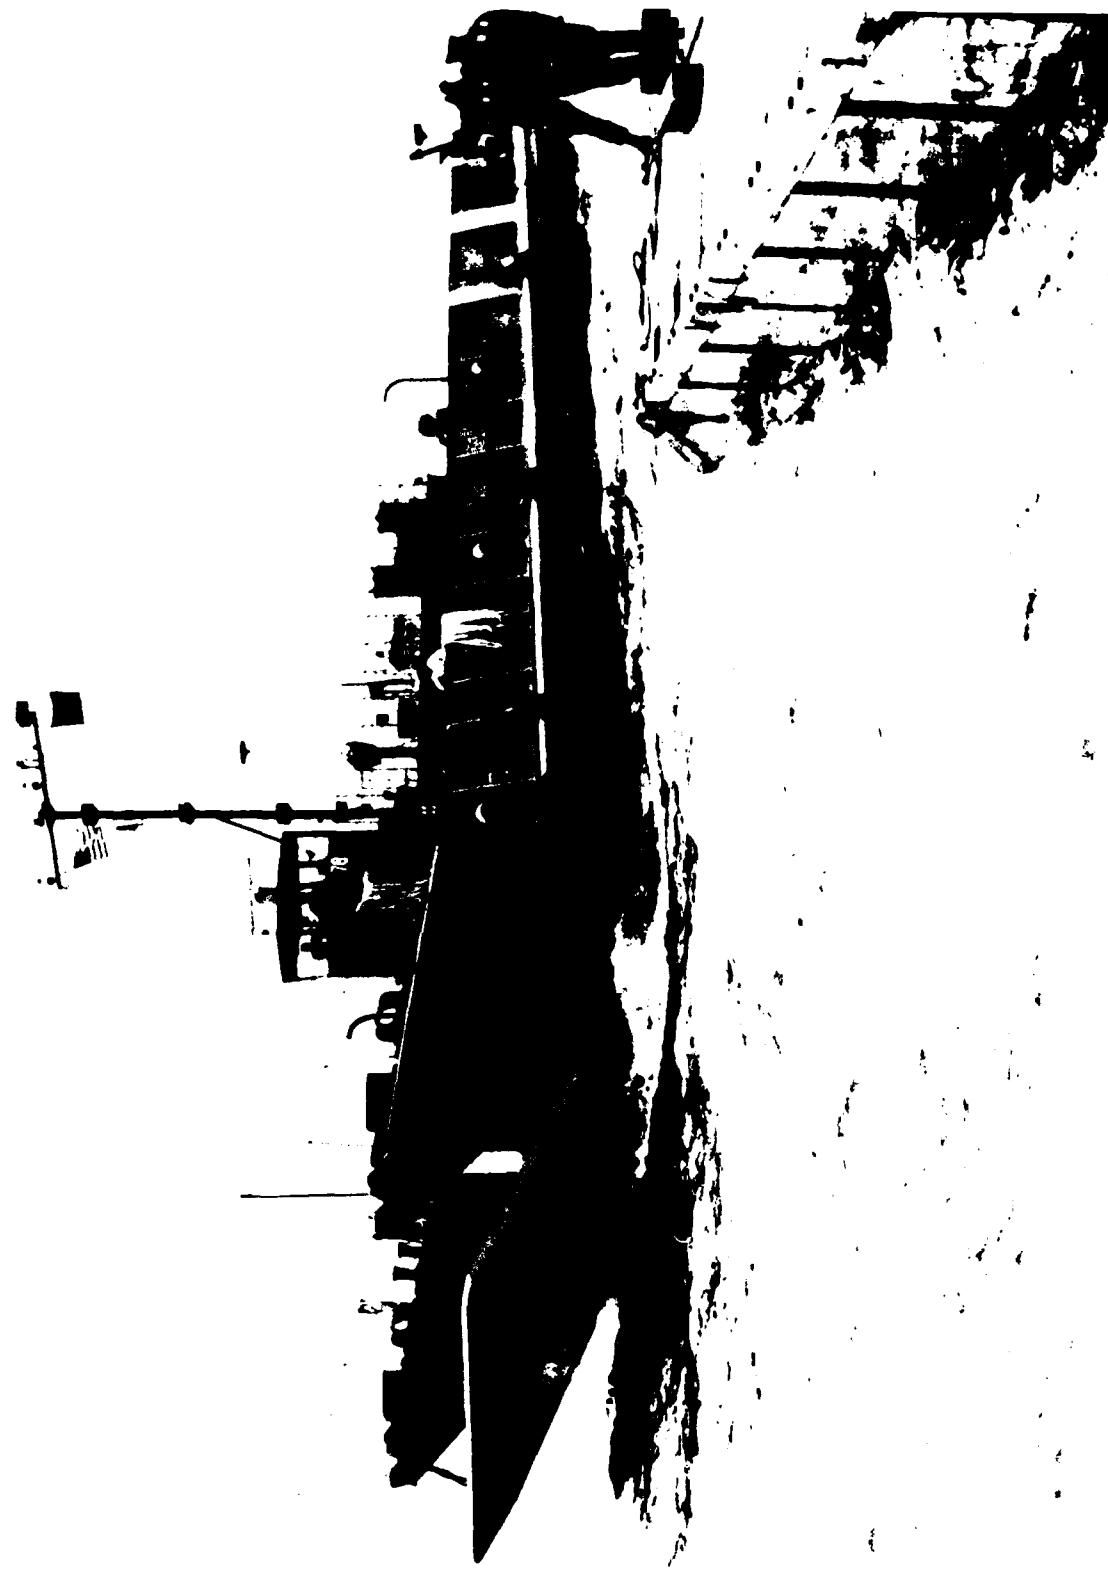
Only one U.S. Army LCU was used during the two days of testing. On the first test day LCU marriages were made both with an alongside Causeway Ferry (see Figure 62) and without the ferry (see Figure 63) with no difficulty. On day 2 the LCU experienced difficulty maneuvering to a marriage both with and without an adjacent windward Causeway Ferry. Two tries totaling 12 min were required to complete the marriage with the adjacent Causeway Ferry (see Figures 64 through 68). When the Causeway Ferry was removed the LCU attempted six tries at marriage to the B section before giving up (see Figure 69 through 71).

Figure 69 - I.C.U. Attempting Marriage with B Section (View 1) (Day 2)

Figure 70 - LCII Attempting Marriage with R Section (View 2) (Day 2)

Figure 71 - ICP Attempting Marriage with B Section (View 3) (May 2)
